SELLENRIEK DAM

FRANKLIN COUNTY, MISSOURI

MO. 31048

**PHASE 1 INSPECTION REPORT
NATIONAL DAM SAFETY PROGRAM**

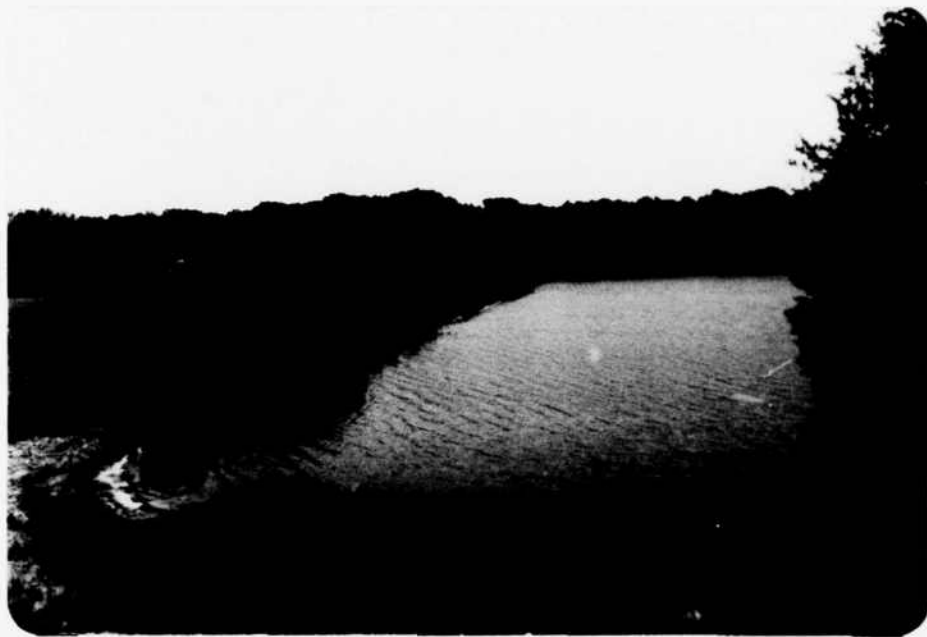
- (2) Upstream Slope. The upstream slope is well vegetated with adapted grasses. A few small trees and shrubs are growing along the water line. Considerable erosion of the face has occurred at or just above the normal pool elevation (elev. 652-653). A few muskrat burrows were noted along the water line. No slumps or other deformations were noted on the upstream slope.

PHOTO NO. 2 - UPSTREAM SLOPE FROM LEFT ABUTMENT

- (1) The activities of the muskrats on the embankment should be curtailed in the near future.
- (2) Trees should be removed from the embankment slopes and measures taken to prevent their recurrence and to control the erosion on the upstream face of the dam.
- (3) A program of periodic inspection and maintenance implementation should be initiated to control these minor deficiencies.

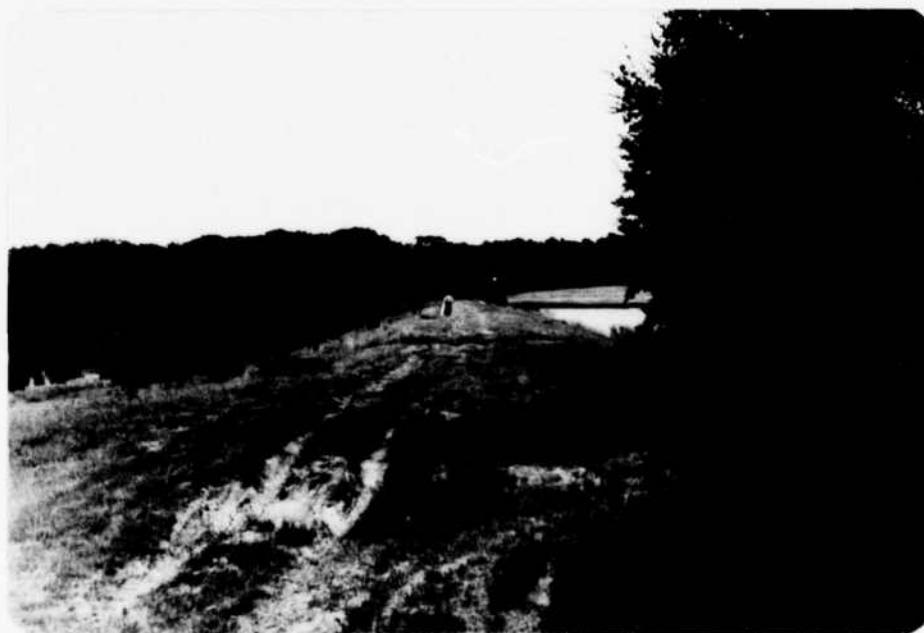
- (3) Crest. The crest is plated with cherty limestone gravel and serves as a roadway. The crest also supports a fair cover of adapted grasses. No cracks or indications of deformation were noted on the crest. The crest is remarkably level for a non-engineered dam with one small swag at elevation 657 ft. and the remainder of the crest at 657.5 ft.

PHOTO NO. 5 - CREST OF DAM FROM LEFT ABUTMENT

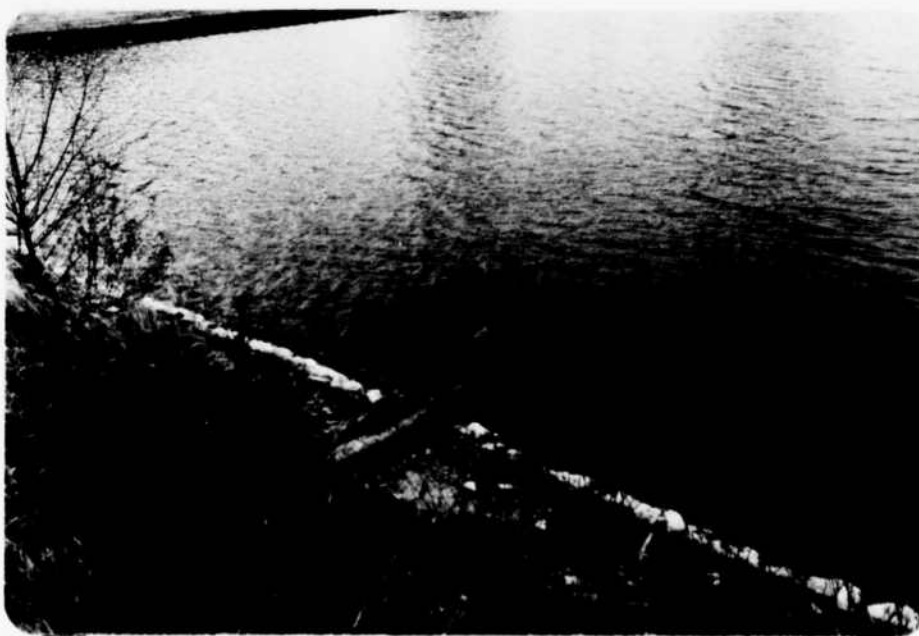
- c. Visual Observations.
 - (1) The spillway pipe appeared to be in good condition. A trash rack was located on the hooded inlet and was clear of debris.

PHOTO NO. 7 - INLET OF PIPE SPILLWAY

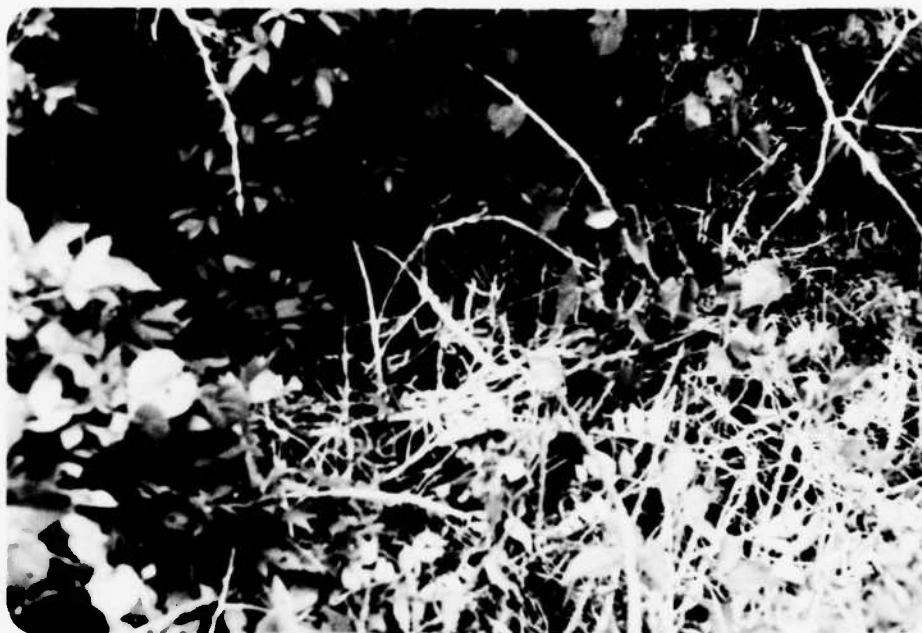
- (1) The principal spillway is uncontrolled and consists of a 12 inch welded steel pipe with hooded inlet passing through the dam. The inlet is covered with a wire mesh trash guard which was open. No deterioration of the steel pipe was noted. The scour hole and surrounding area at the outlet end is overgrown with brambles and brush. The reservoir level was 0.7 ft. below the inlet of the spillway at the time of inspection. The bottom of the outlet scour hole and downstream channel were dry when inspected.

PHOTO NO. 10 - OUTLET OF PIPE SPILLWAY

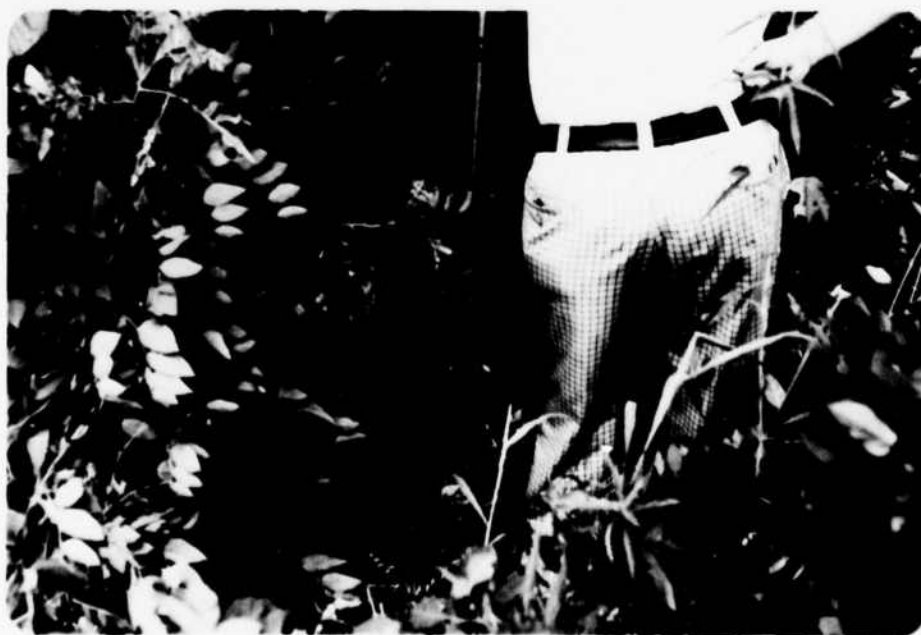
PHOTO NO. 11 - OUTLET OF PIPE SPILLWAY
